Expedient Shelter Construction and Occupancy Experiments

OAK RIDGE NATIONAL LABORATORY

HEALTH PHYSICS DIVISION
EMERGENCY TECHNOLOGY SECTION

MARCH 1976

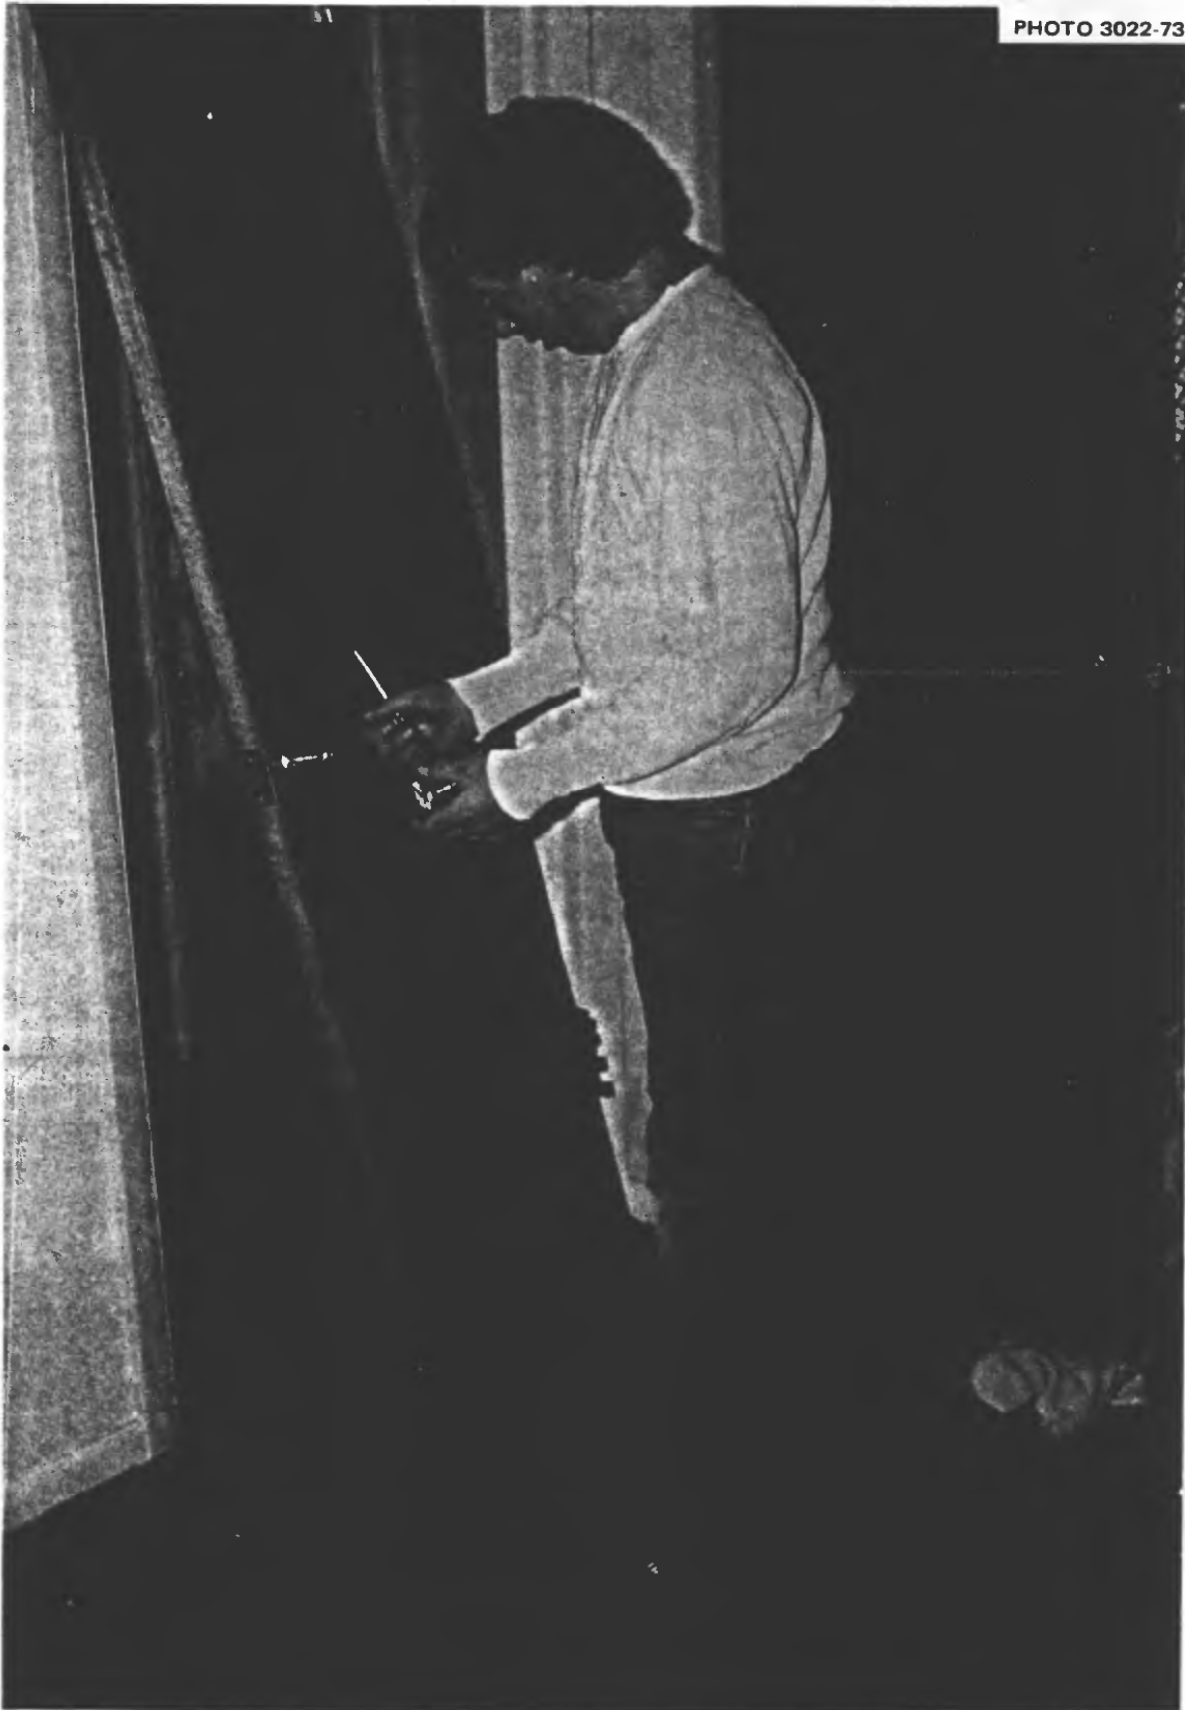
Fig. 2.1. Start by an untrained, unskilled family of the second proof-testing of the written instructions for building a Door-Covered Trench Shelter. Starting at 6 AM on November 24, 1973, son Tad, age 14, and other children removed the doorknobs from one of the six interior doors that this fatherless family of six readied for use.

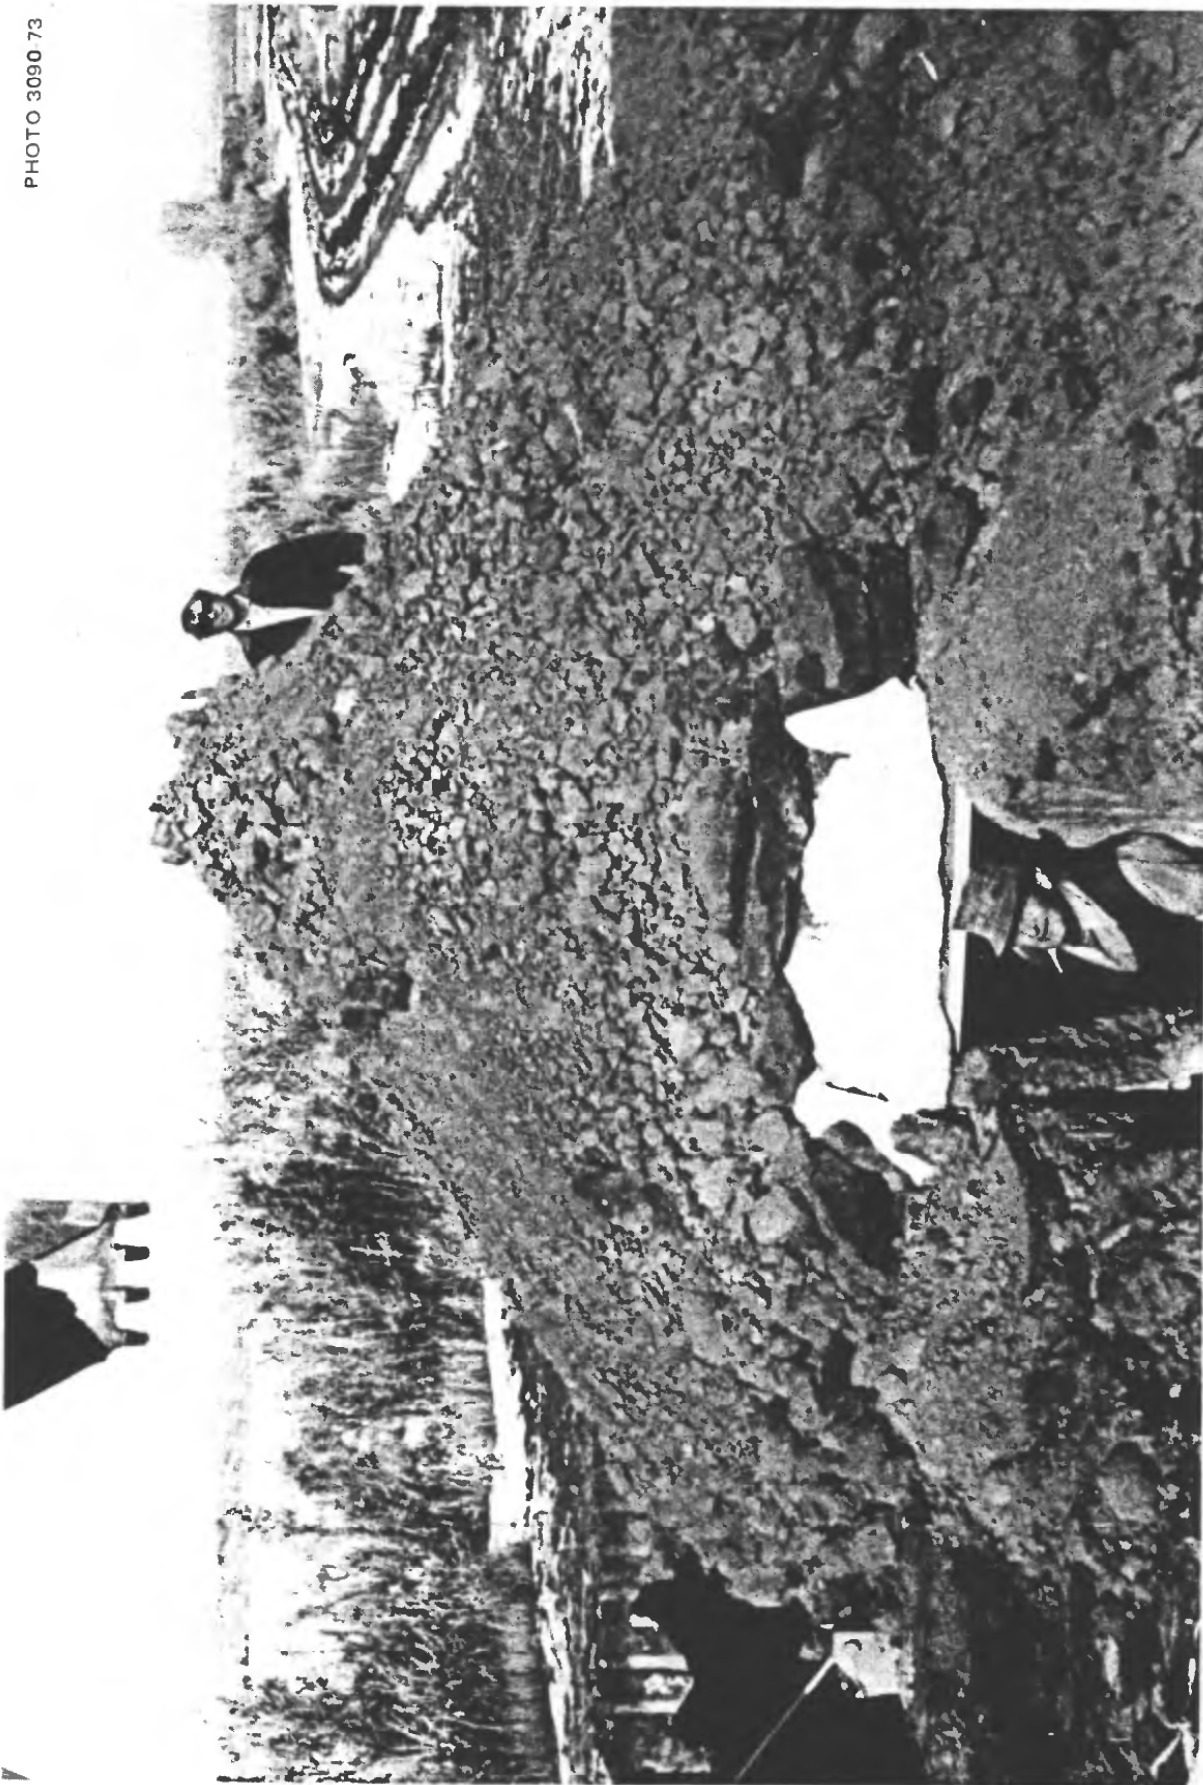
Fig. 3.2. View of the same shelter from the entryway end. An observation trench had been dug out from the entryway, so that deflections of the roof doors could be observed safely.

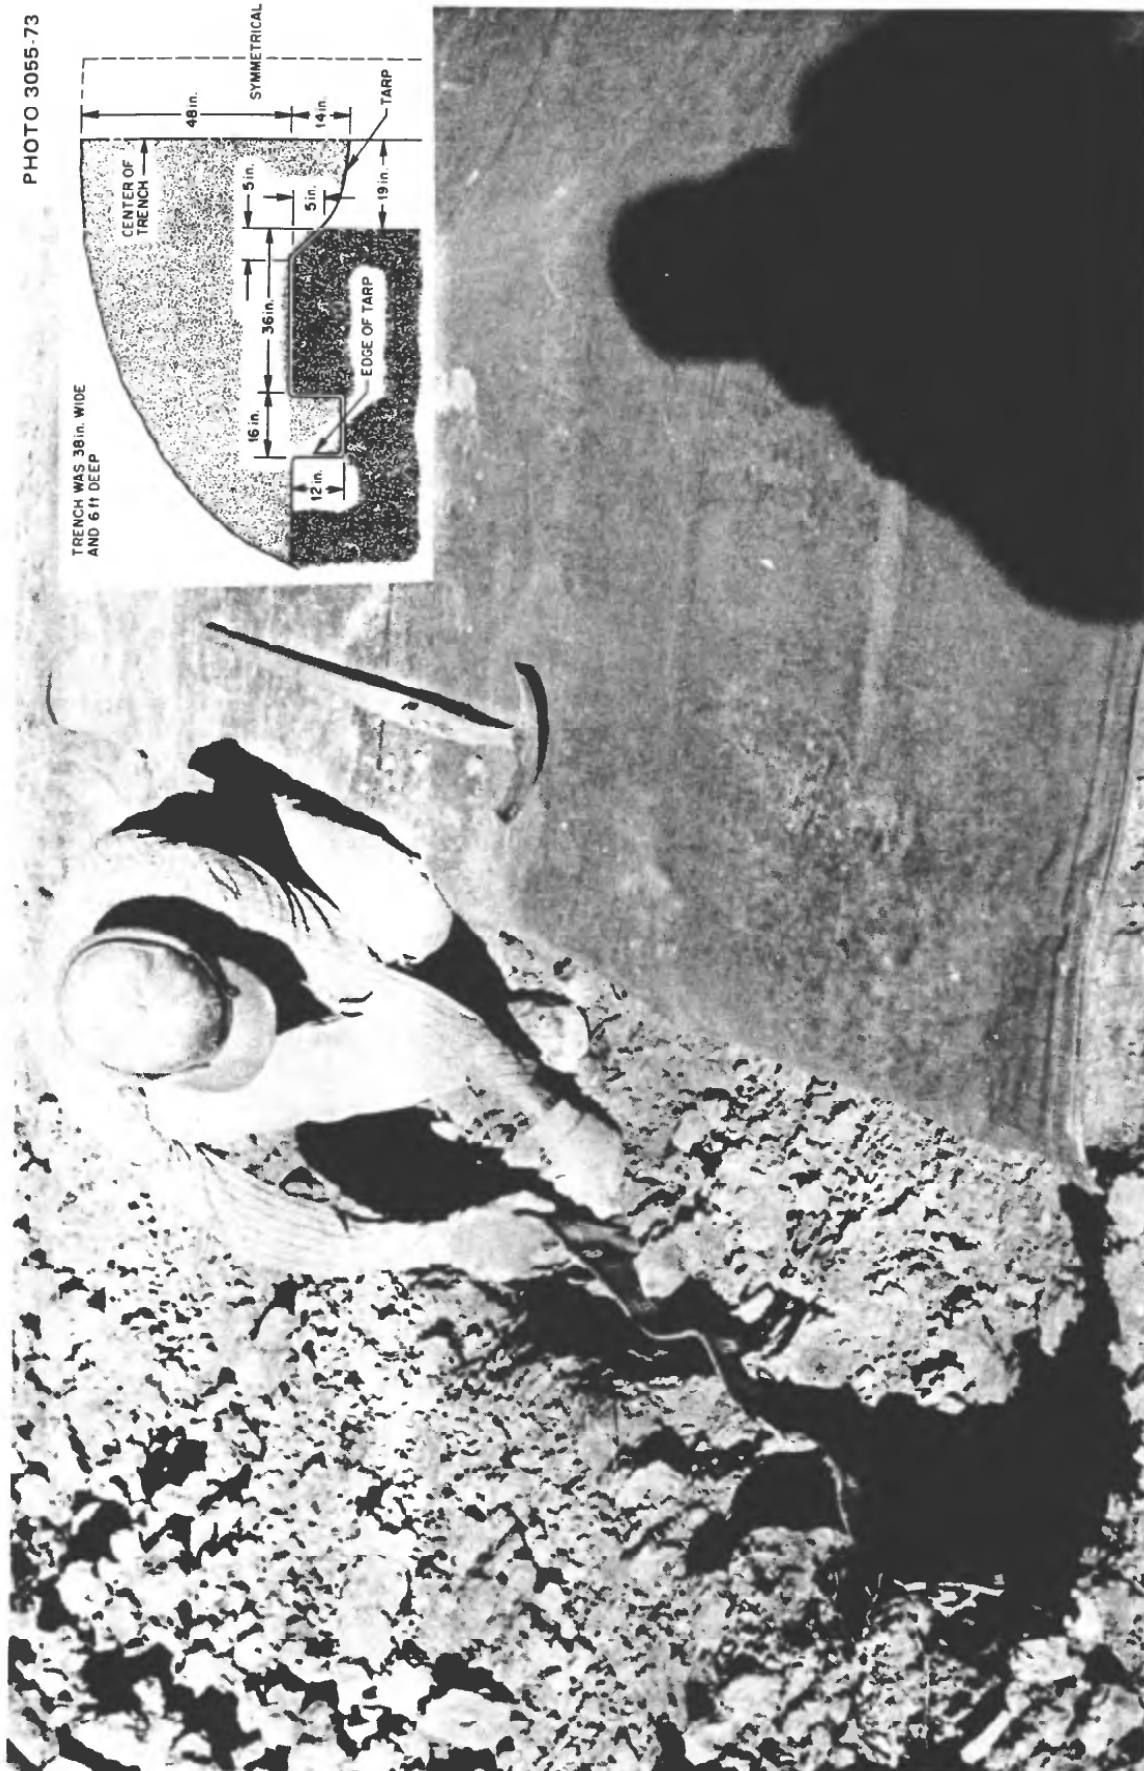
Fig. 3.11. Building the best of two successful Tarp-Roofed Trench Shelters constructed on Dec. 1, 1973, on the Kearny farm near Montrose, Colorado. C. H. Kearny designed this shelter after the November tests of the Door-Covered Trench Shelter had convinced him that, if the principles of earth arching and friction are used properly, then blast shelters can be built in many areas by roofing a trench with only a tarp or a strong rug, and then intelligently covering the tarp or rug with earth.

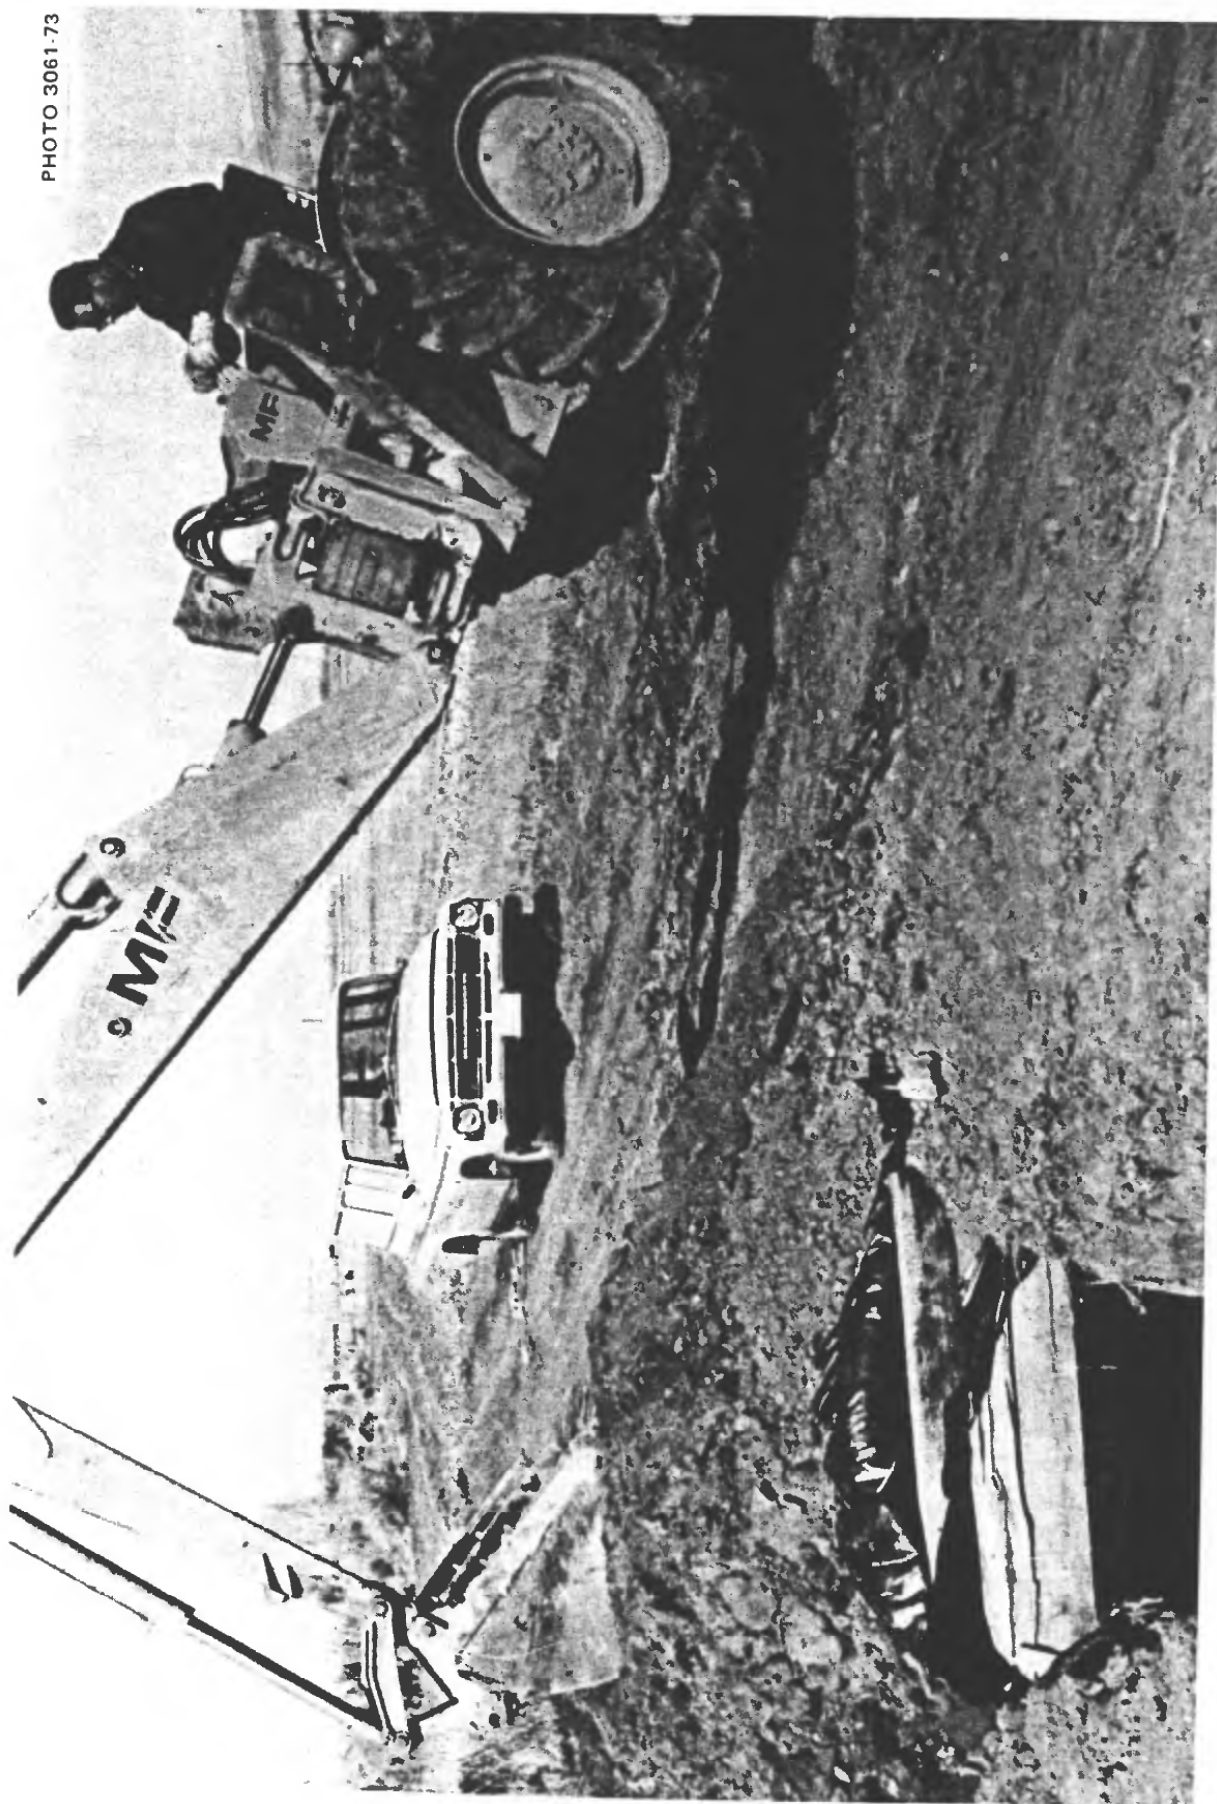
Fig. 3.13. Stressing the Tarp-Roofed Trench Shelter, a 6-ton backhoe, supported only by its buckets, pressed down repeatedly with its front bucket on a 62-in.-deep mound of loose earth. The mounding of loose earth caused the tarp to bow downward (sag) into a catenary curve. The compaction caused the tarp to stretch, resulting in an increase of the maximum sag from 8 to 14 in.

Two-inch-wide strips cut from this 12-oz cotton duck tarp were subsequently stressed to failure in the Metallurgy Test Laboratory of ORNL. The ultimate strength was found to average only about 190 lb per 2-in.-wide strip, or 1140 lb per 12-in.-wide strip when subjected to ideal straight-pull stressing.

Calculations using these optimum figures show that without earth arching the Tarp-Roofed Trench Shelter would have failed under the loads it was subjected to on December 1.

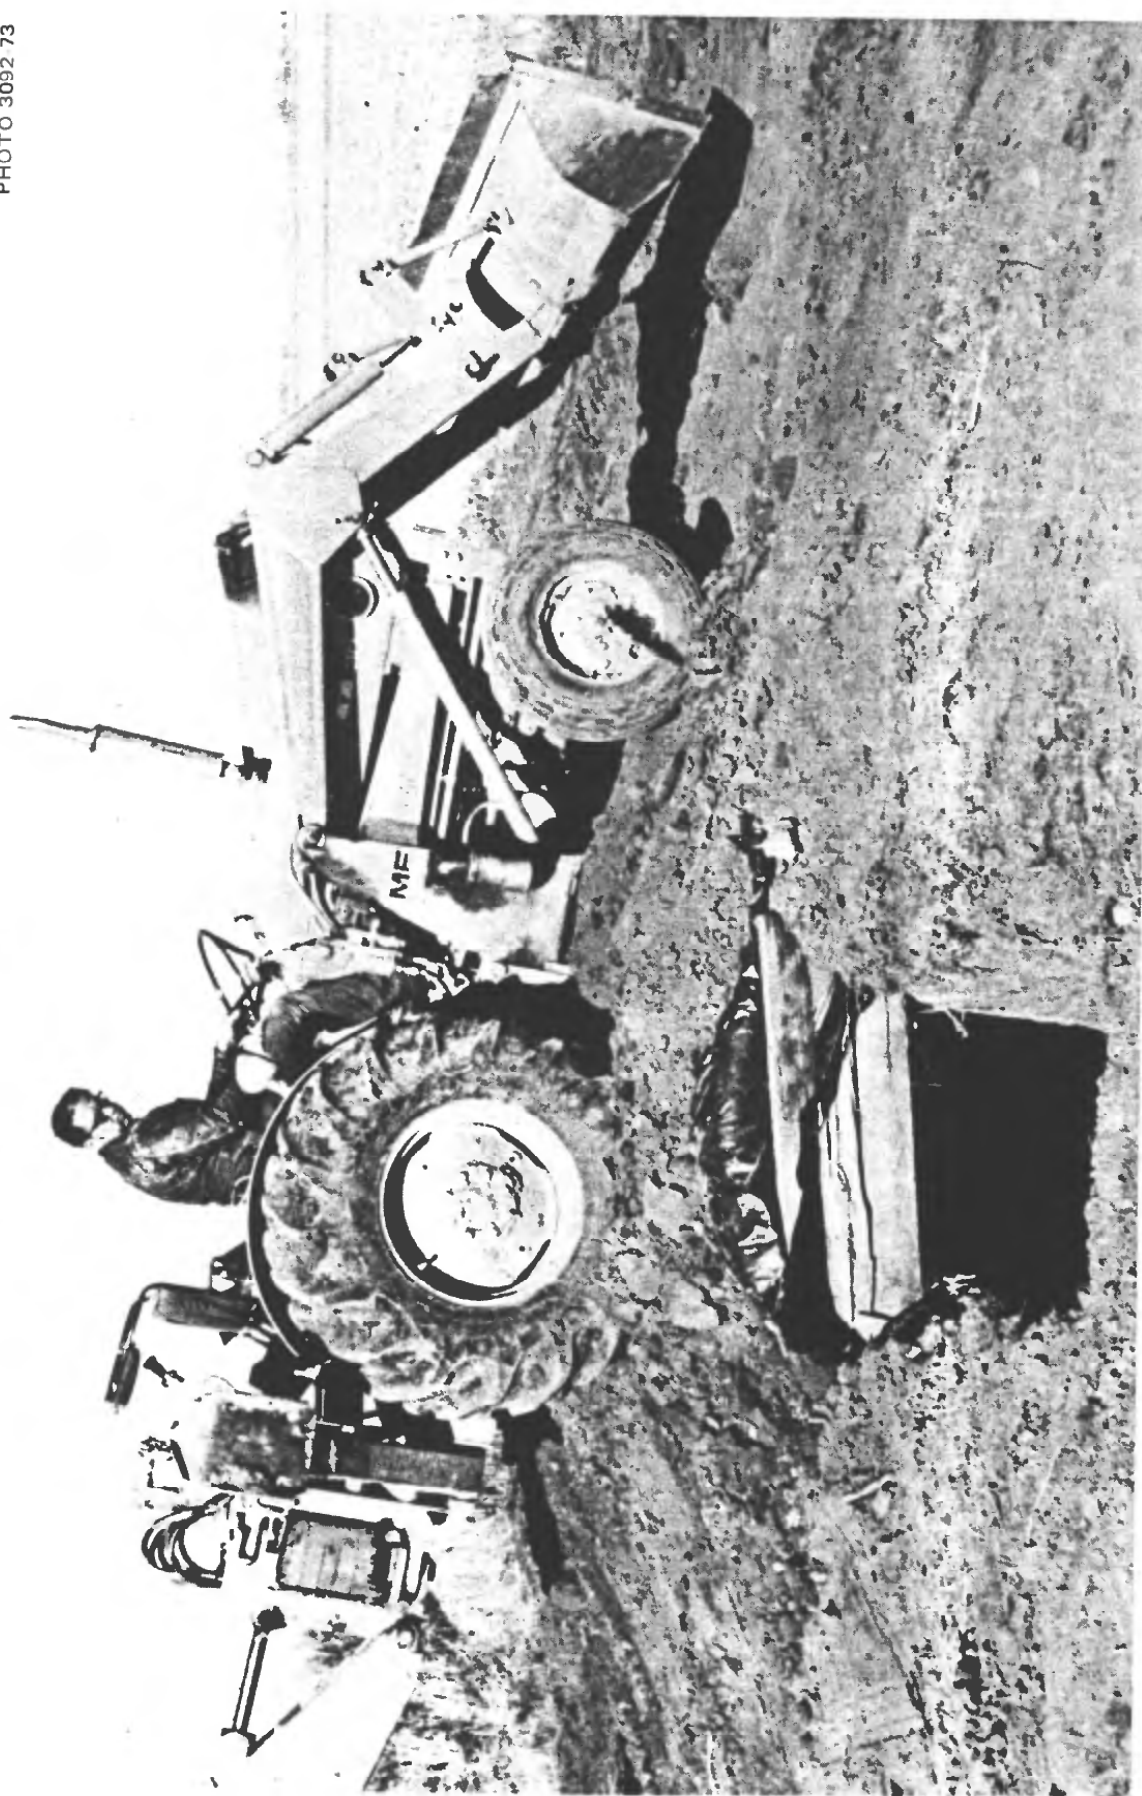
Fig. 3.14. Stressing the Tarp-Roofed Trench Shelter, after the thickness of its earth cover had been reduced to about $3\frac{1}{2}$ ft, by driving a 6-ton MF-30 backhoe back and forth across it. The downward bow, or sag, of the tarp catenary remained the same (14 in.). Because Kearny wanted to see whether or not the tarp edges in the small earth-filled side trenches had moved, no more of the earth cover was removed preparatory to more severe loading tests. The tarp was unearthed by the backhoe and hand labor; the tarp edges in the small trenches had not been moved, nor had the compacted earth in the two small side trenches been disturbed by the inward pulls on the tarp produced by the loading tests.

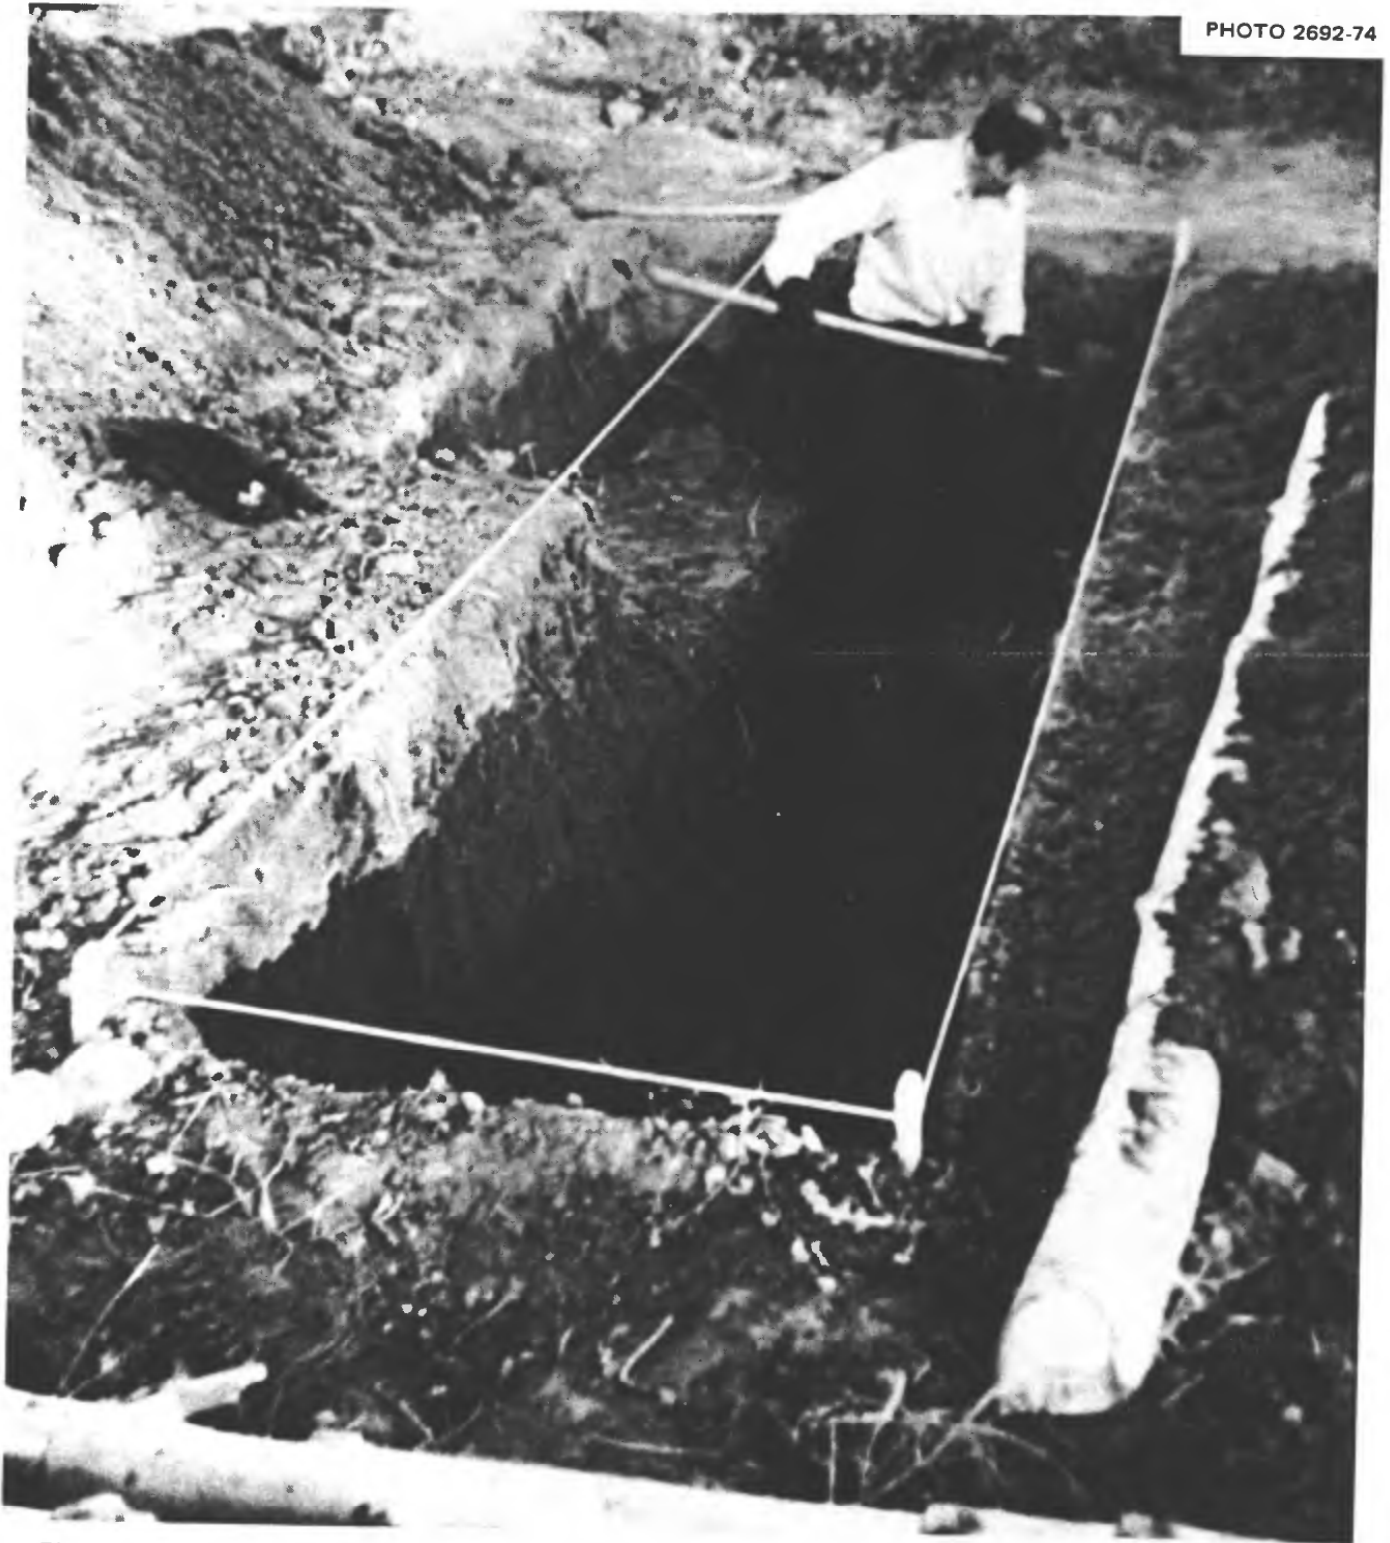
Fig. 4.4. Expanding the shelter room to its full specified width of $3\frac{1}{2}$ feet, and to its $4\frac{1}{2}$ -ft depth. This intelligent man made unnecessary work for himself by not following the instructions to cut a $3\frac{1}{2}$ -ft stick, and then use it repeatedly to be sure the trench was being dug full width.

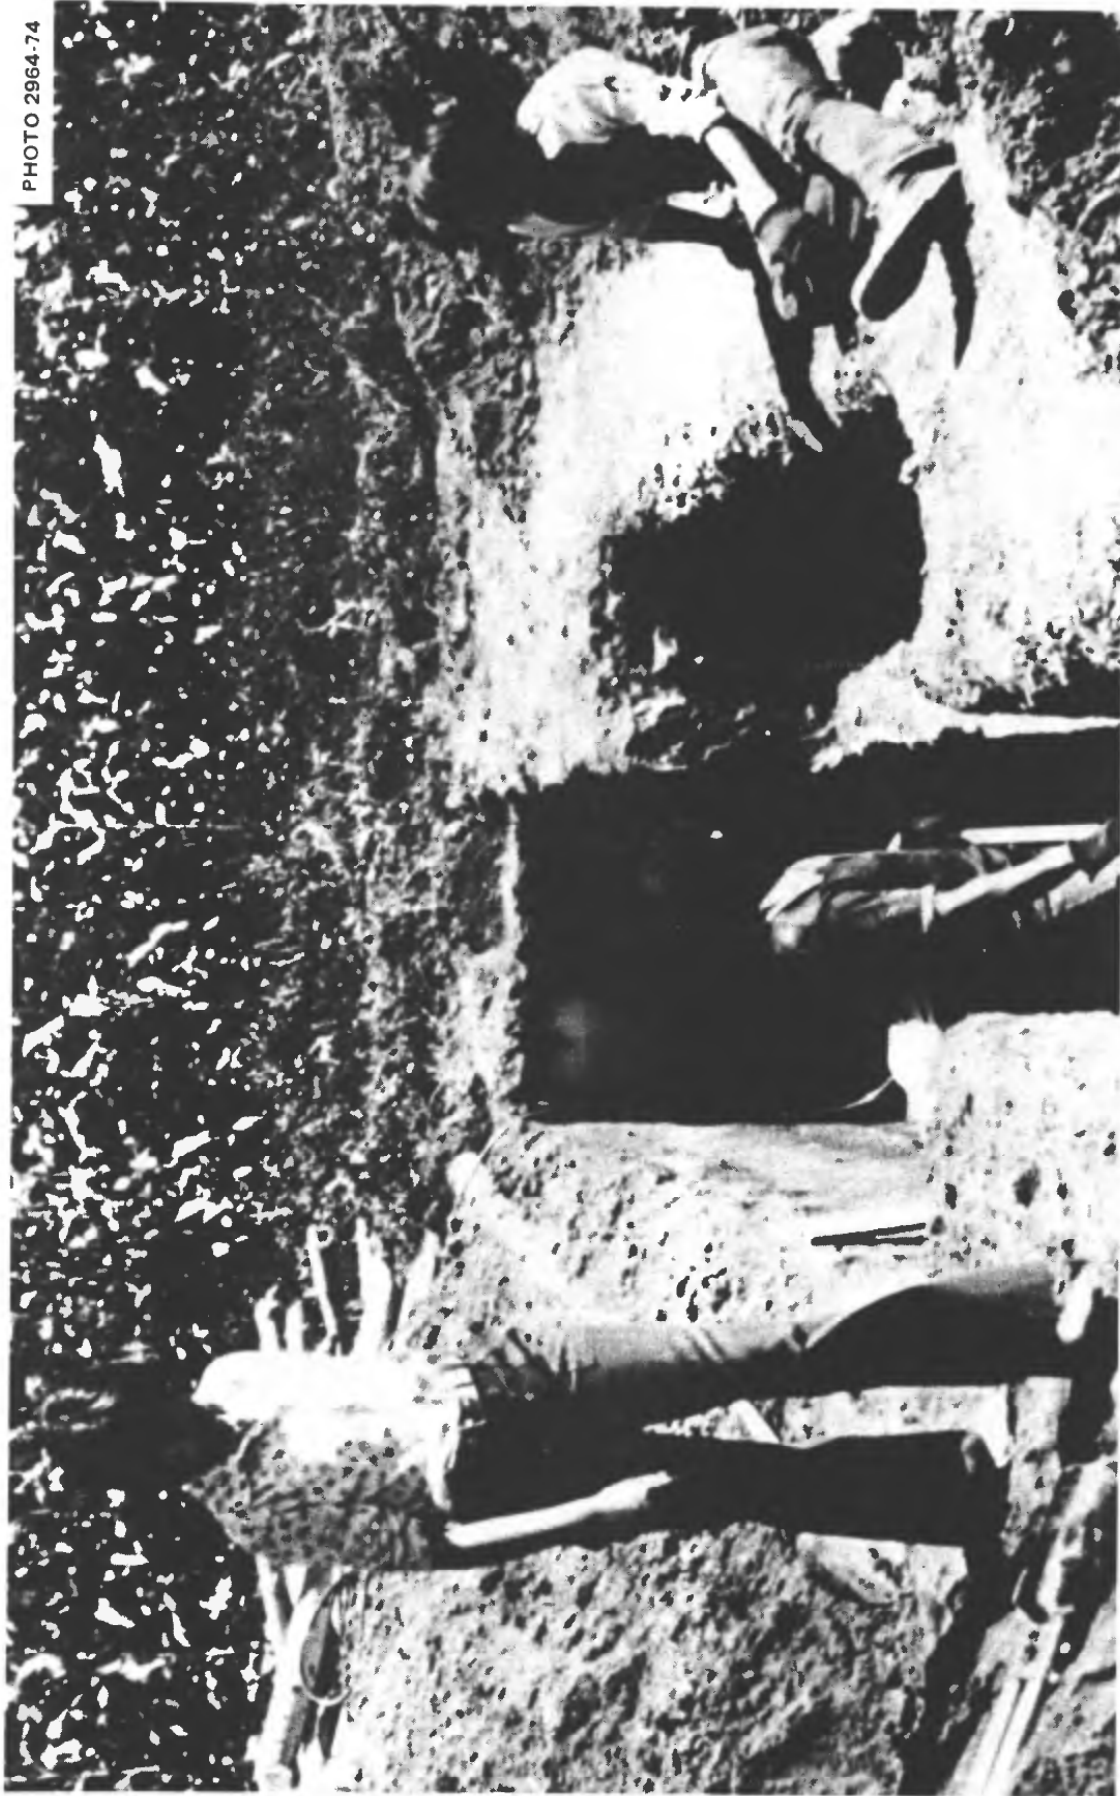
Fig. 4.5. The small ledgelike excavation on the side of the main trench was dug by Kearny to provide himself with a place to sleep and to observe the shelter-occupancy test. This sleeping ledge was 2×8 ft, providing a height to the log roof of only 2 ft. After Kearny got a sore neck from turning around periodically on this sleeping ledge, with only a 24-in. ceiling, during the 77 hours of shelter occupancy, he concluded that such sleeping ledges should be dug to provide a 30-in. ceiling.

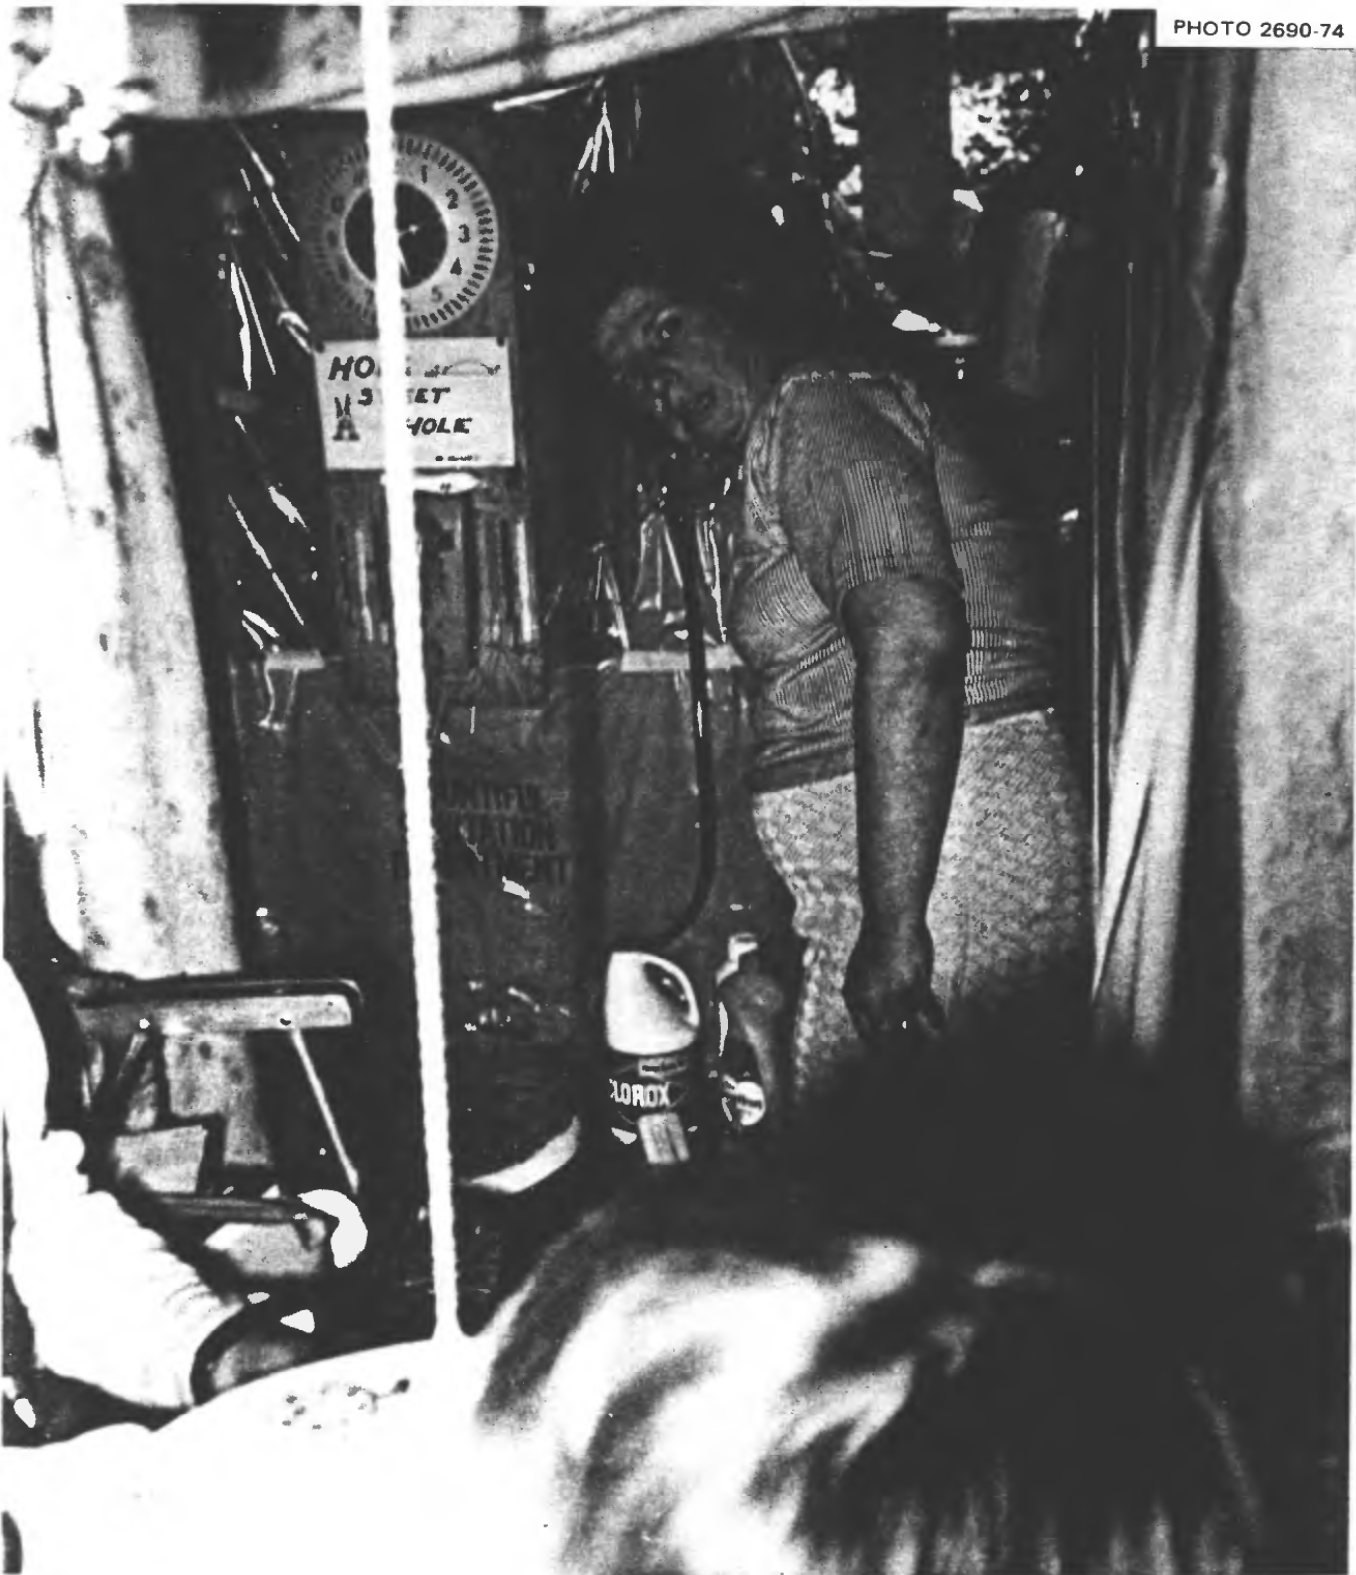
Fig. 4.23. The mother standing in the 18-in.-deep stand-up hole next to the toilet. Note the air-duct-emergency exit, shown above the mother's shoulders, with a piece of toilet paper hanging from its roof to indicate air movement.

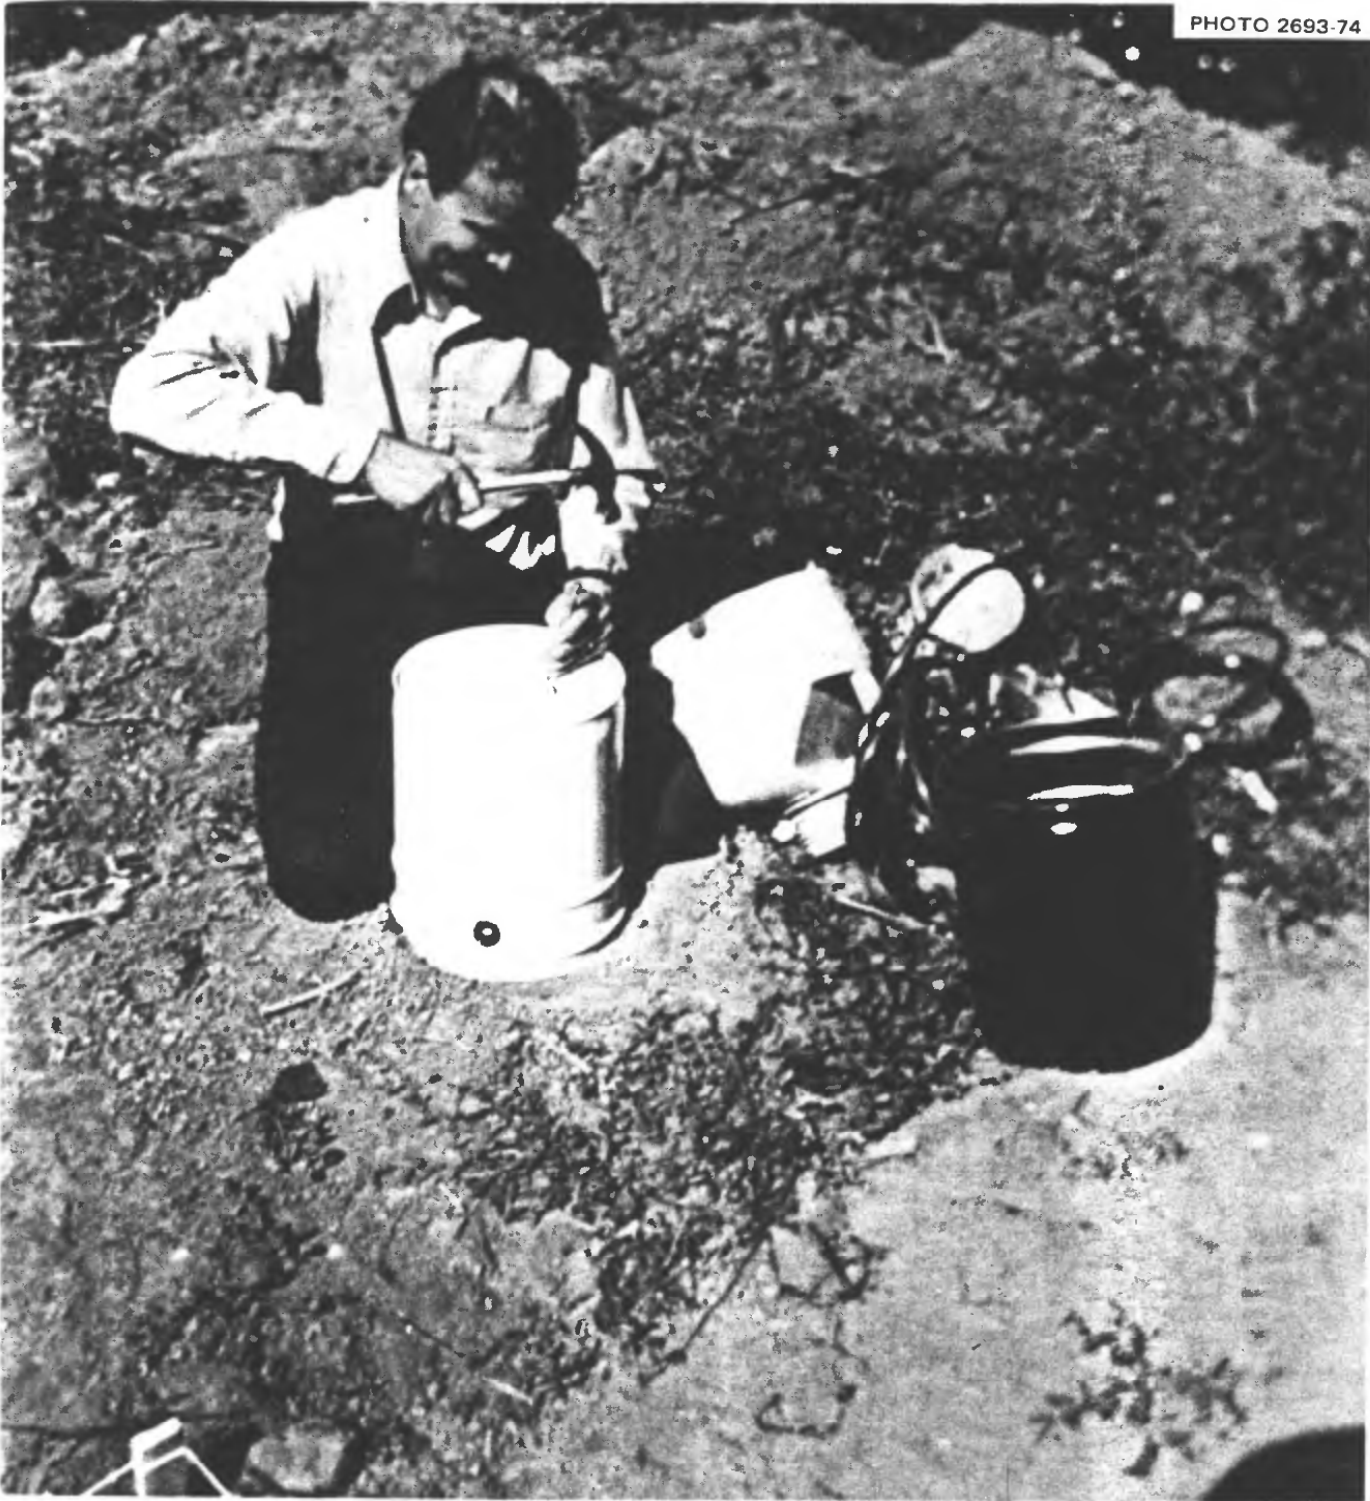
Fig. 4.25. The father starting work, with cold chisel and hammer, on his clever design of an odorless expedient toilet. In order to determine how long it would take to build and install this toilet under field conditions, he brought from his home the two 5-gallon cans, a 5-gallon plastic water jug (shown upside down), a garden hose, a complete toilet seat, an uncut piece of plywood, a tube, some cord, and freezer tape — all the materials needed to build this toilet.

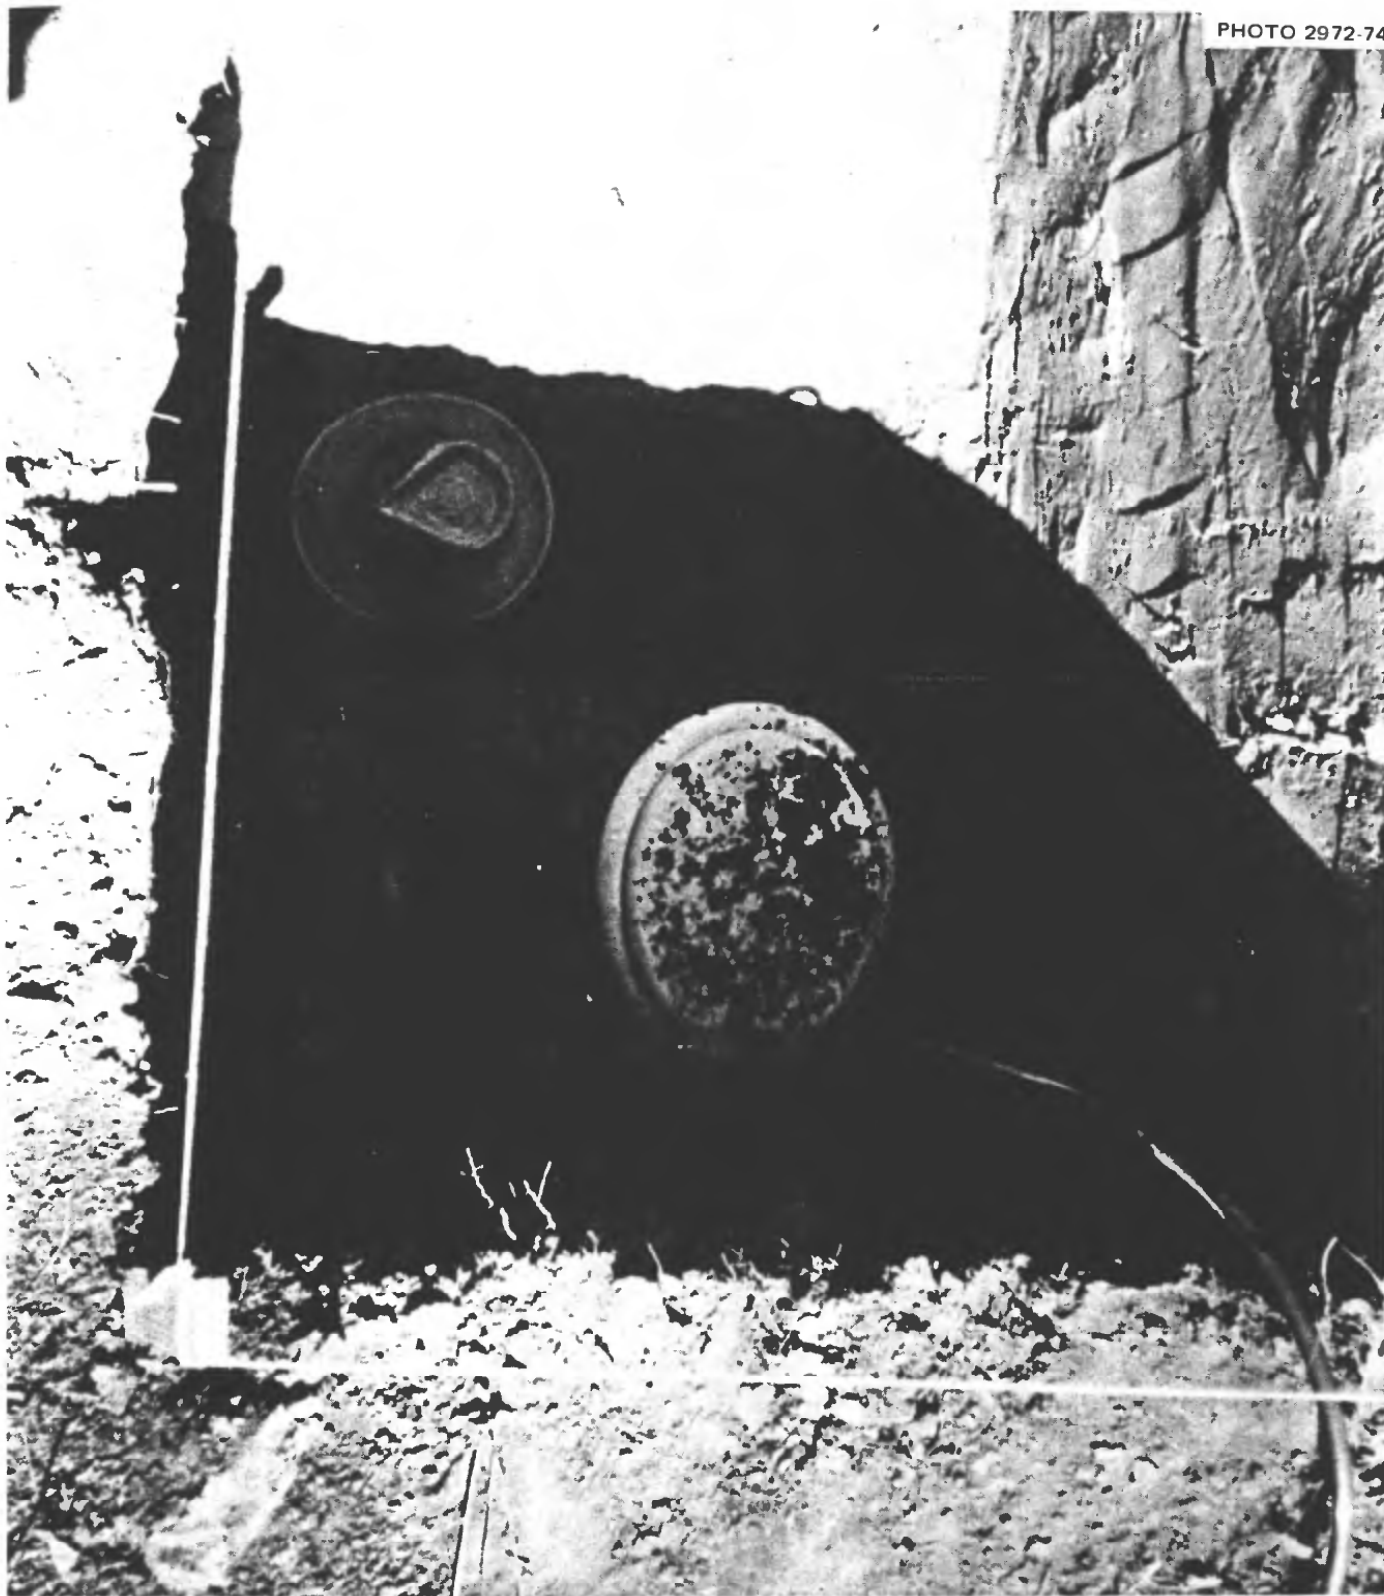
Fig. 4.29. View looking straight down on the installed toilet and its seat. The two assembled 5-gallon cans and the toilet bowl had been placed in a hole dug in the bottom of the shelter. A piece of $\frac{1}{2}$ -in. plywood, in length equal to the 42-in. width of the shelter room and about 20 in. wide, served as the horizontal surface to which the toilet seat was attached. An appropriately sized, roughly elliptical hole had been cut in this plywood with a brace and bit and a cold chisel. The plywood base of the toilet was at floor level. Note the vent hose.

The 42-in.-wide threshold board is seen on the far edge of the stand-up hole. This and other threshold boards were installed on the edges of earth steps, and prevented the earth edges from being broken off, even after having been used for days.
